Report of Dam Safety Assessment
of Coal Combustion Surface Impoundments
Interstate Power and Light Company
Sutherland Generating Station
Marshalltown, IA

AMEC Project No. 3-2106-0191

October 2012

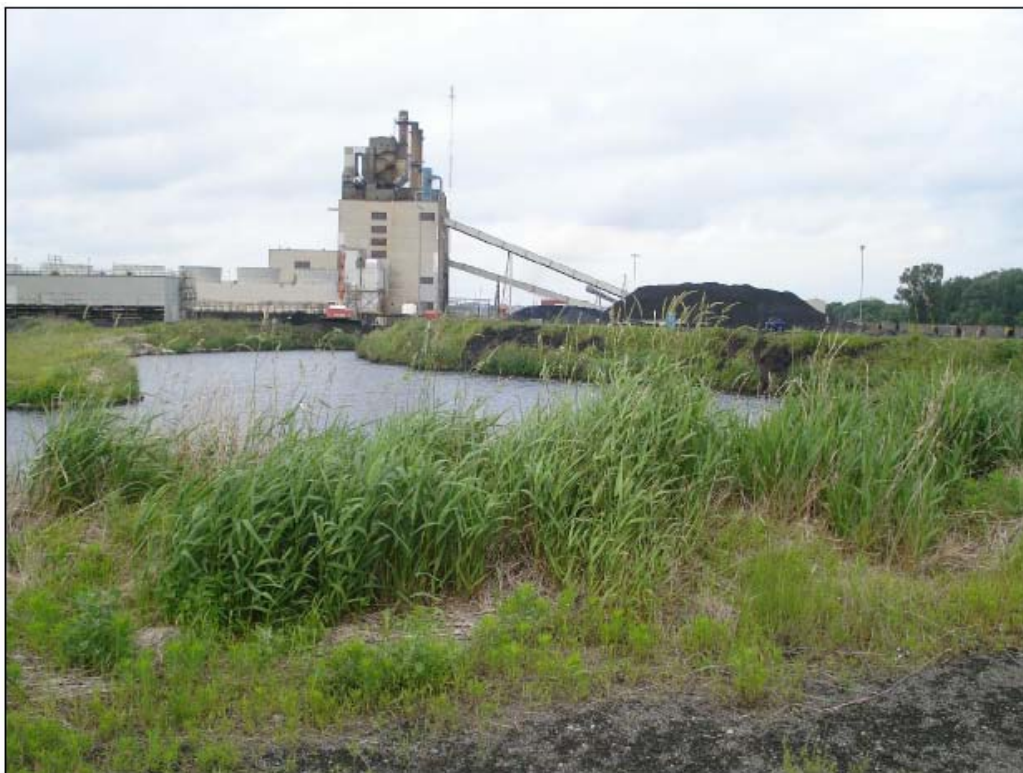
slopes observed at isolated locations and in reaches. Notable reaches include the following locations:

- Area beginning at the inlet from the North Pond extending northeast along the embankment below the ash stockpile area. See photo below presented as SECP-1 in Appendix B.

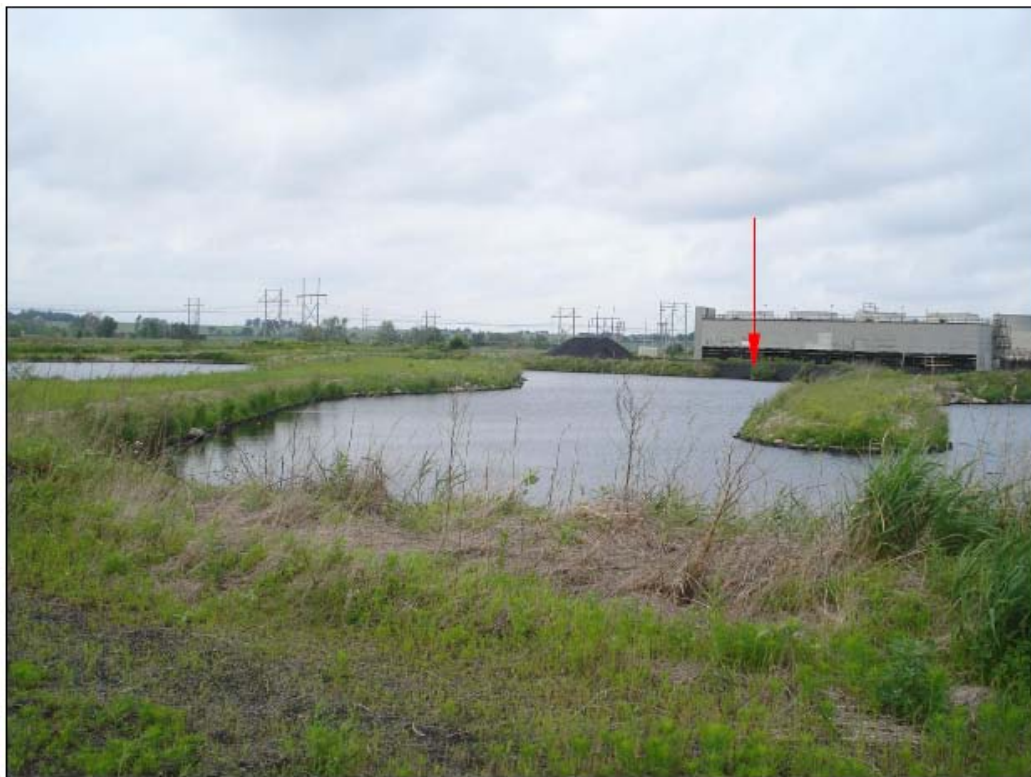
- Area in the vicinity of the inlet from the South Pond and to the north. See Photo SECP-2, below, and Photo SECP-3 presented in Appendix B.

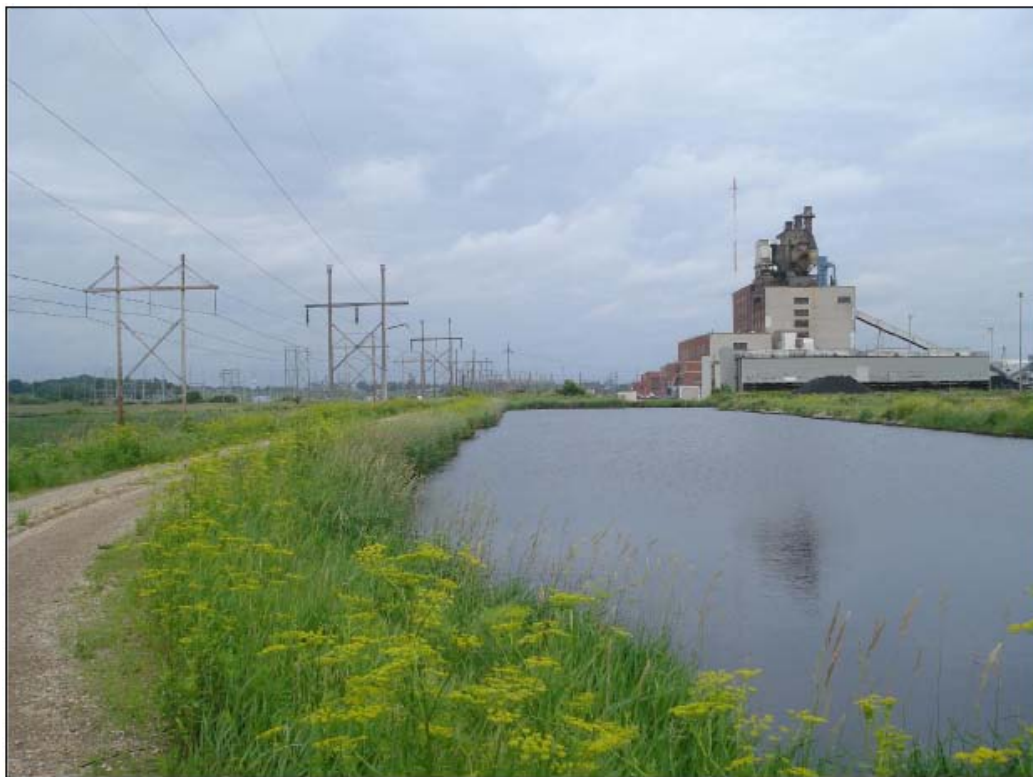
- Local area located to the north of the southwest corner. See Photo below presented as Photo SECP-4 in Appendix B.

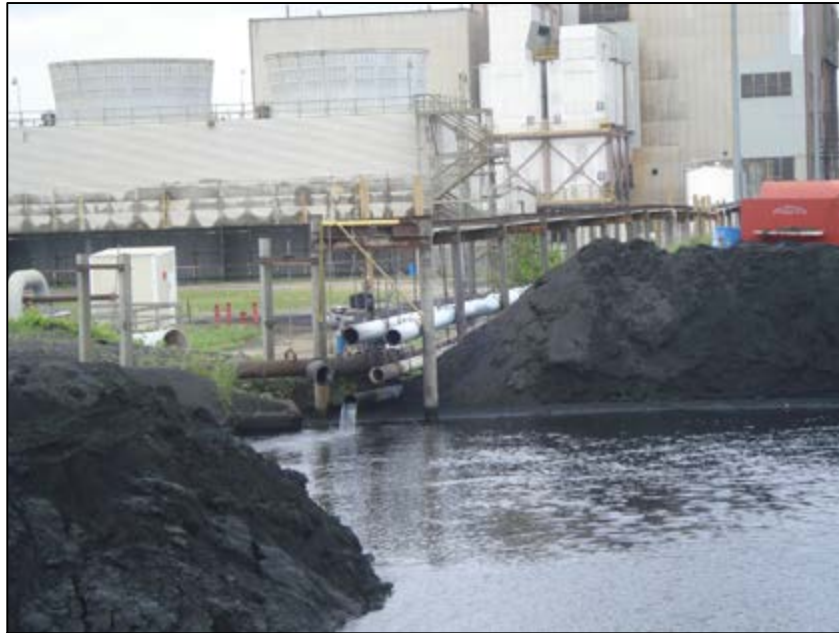
NP-1
LOOKING WEST AT CCW AND OTHER
WASTESTREAM INLET PIPES FROM PLANT

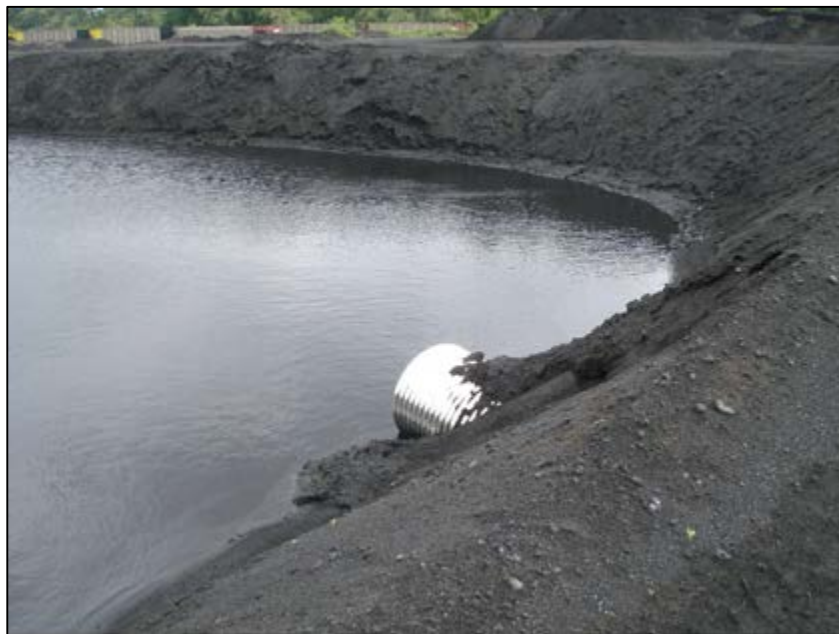
NP-2
LOOKING NORTH AT INLET OF OUTLET PIPE

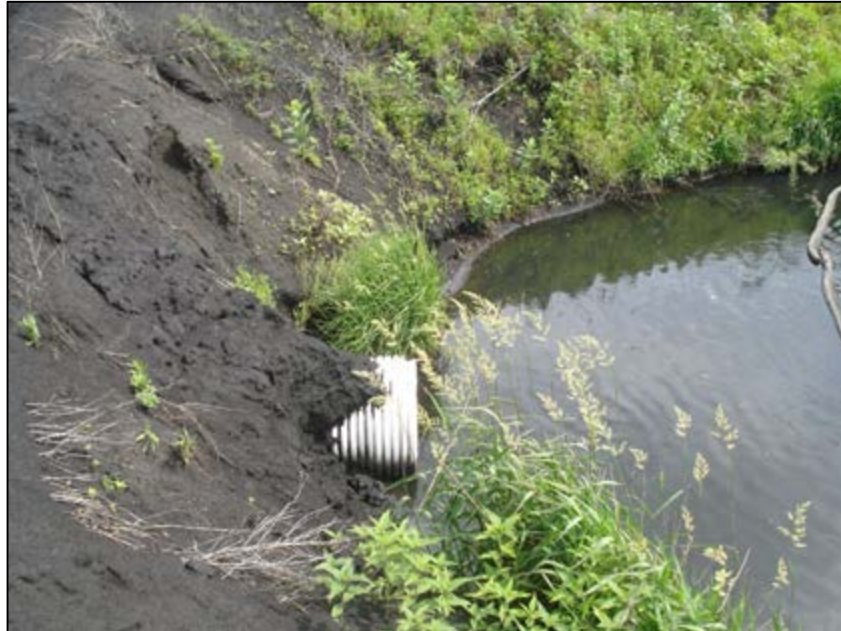
NP-3
LOOKING EAST AND DOWN AT OUTLET OF PIPE
FROM NORTH POND TO SECONDARY POND

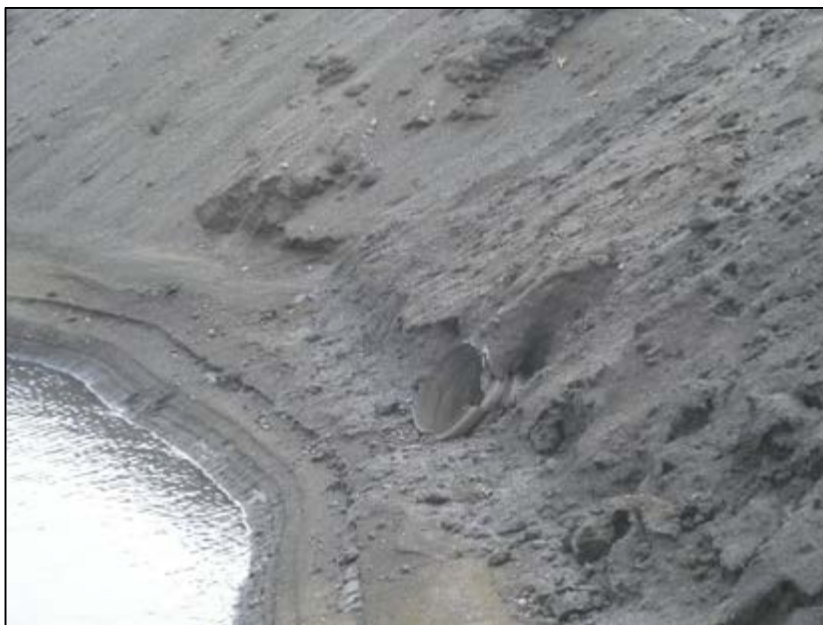
SP-2
FROM SOUTH CREST LOOKING EAST AT
INLET OF OUTLET PIPE FROM SOUTH POND

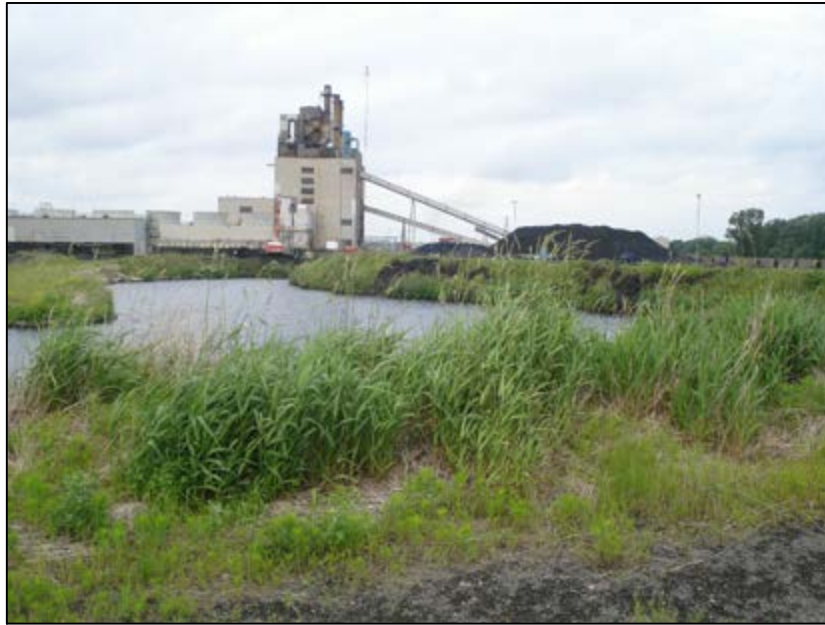
Since the southwest and northwest embankments are situated well inside the original embankment, the crests consisted of ash. The area at the crest/entrance road near the southwest corner of the secondary pond appeared to be low and sloped to the west and away from the ash management area (Photo SECP-4). The crests of the east and south dikes were covered with gravel and appeared to be in good condition (Photos SECP-15, SECP-21, and SECP-18). Observations and survey information indicate the east and south crest heights maintain or exceed the idealized design elevation of 865 feet. The northwest and west crest generally exceeds this height and grade to the southeast toward the ponds (Photos SECP-1 and SECP-12).

LOOKING WEST AT START OF SECONDARY POND. STEEP/BARE SLOPES ON NORTH INTERIOR EMBANKMENT. NOTE GRADE (TRUCK) TO NORTH

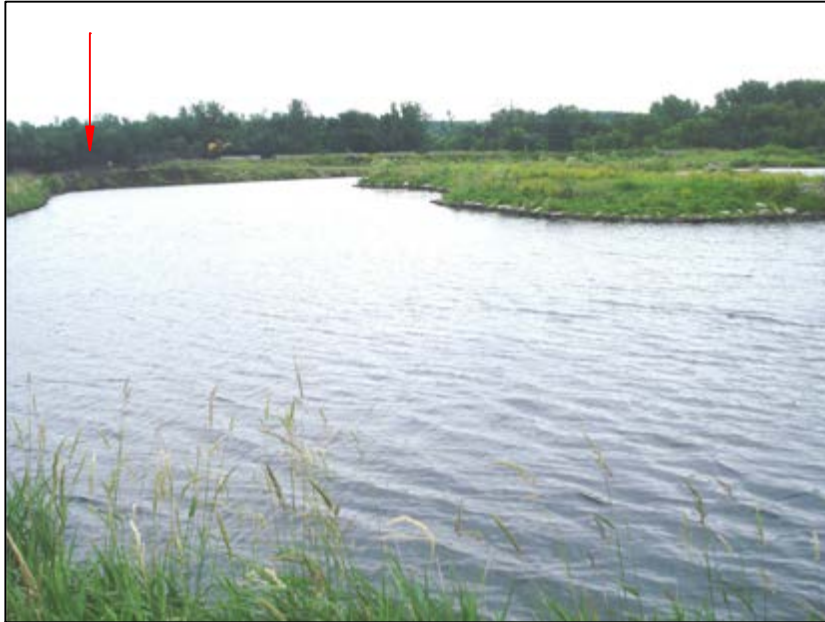
SECP-3

LOOKING NORTH AT INTERIOR AND WEST DIKE US SLOPES OF SECONDARY POND, STEEP/BARE AREA AT INLET FROM SOUTH POND (TOP LEFT)

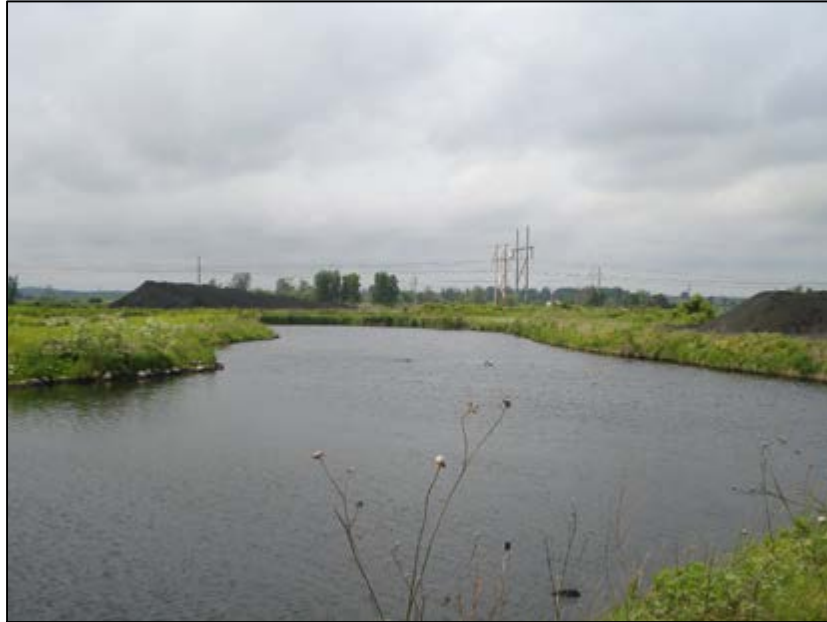
SECP-5
LOOKING SOUTH AT INTERIOR AND WEST EMBANKMENT OF SECONDARY POND

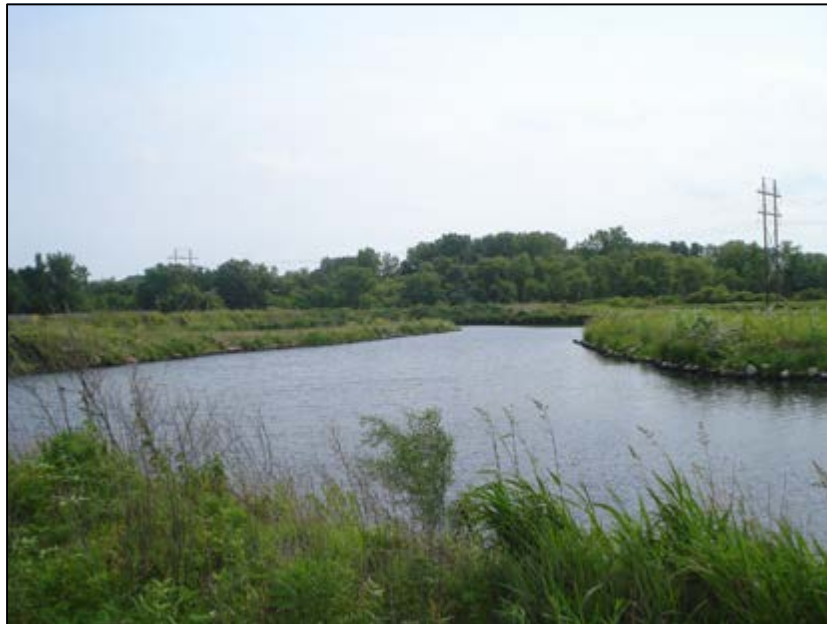
SECP-6
LOOKING NORTHEAST AT WEST UPPER SECTION OF
SECONDARY POND. ROCK AT TOE OF INTERIOR SLOPES

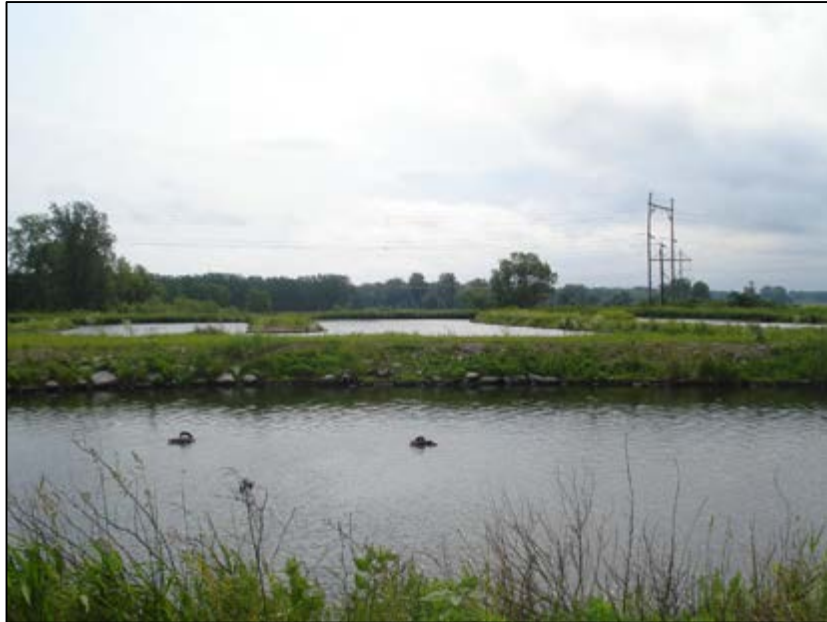
SECP-9
LOOKING EAST AT SOUTH INTERIOR OF SECONDARY POND.
INTERIOR FINGERS COMPLETED IN 2006 IN BACKGROUND

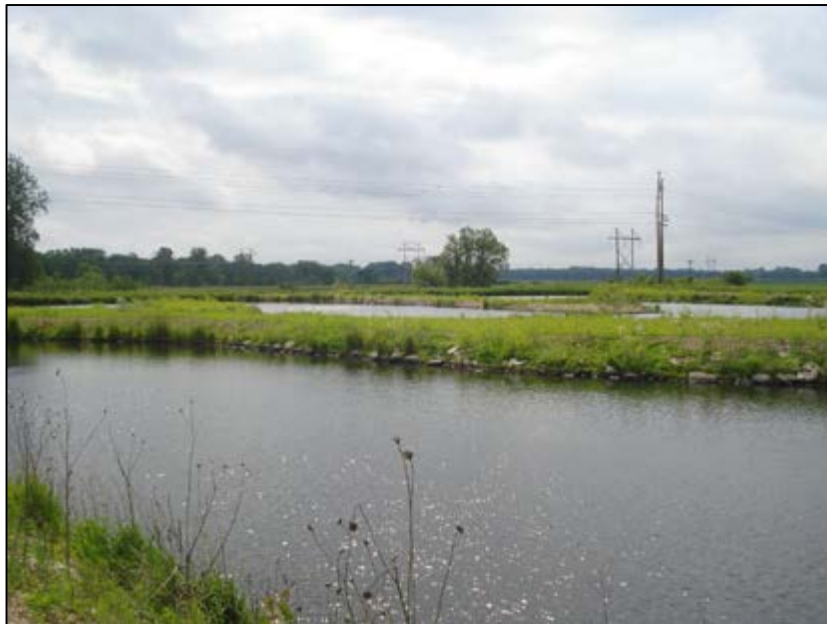
SECP-10
LOOKING EAST-SOUTHEAST AT INTERIOR OF SECONDARY POND.
WEST (START) IN FOREGROUND, EAST (END) IN BACKGROUND

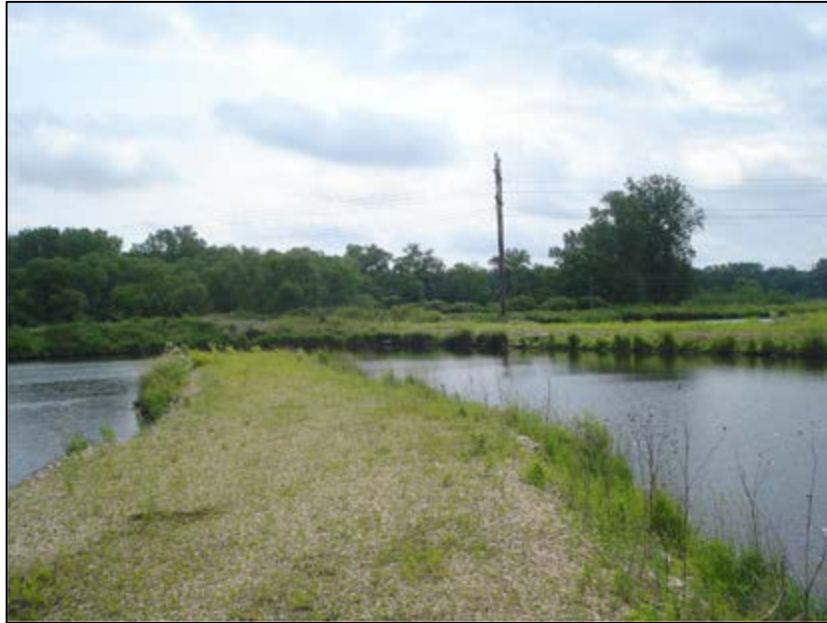
SECP-11
FROM START OF FINGER ACROSS FROM SOUTH POND
LOOKING EAST AT INTERIOR OF POND

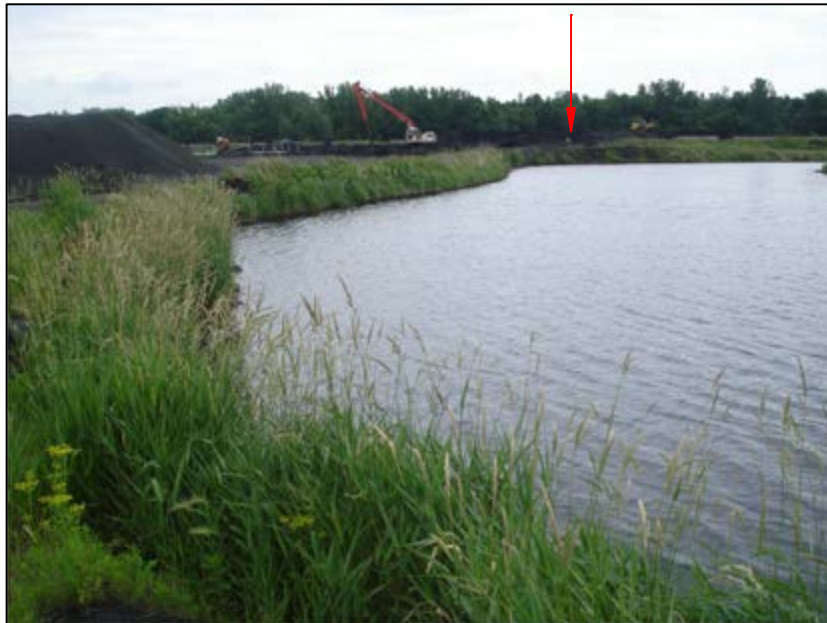
SECP-12
LOOKING NORTH AT US SLOPES OF WEST DIKE OF SECONDARY POND,
TALL VEGETATION, STEEP/BARE AREA AT INLET FROM SOUTH POND

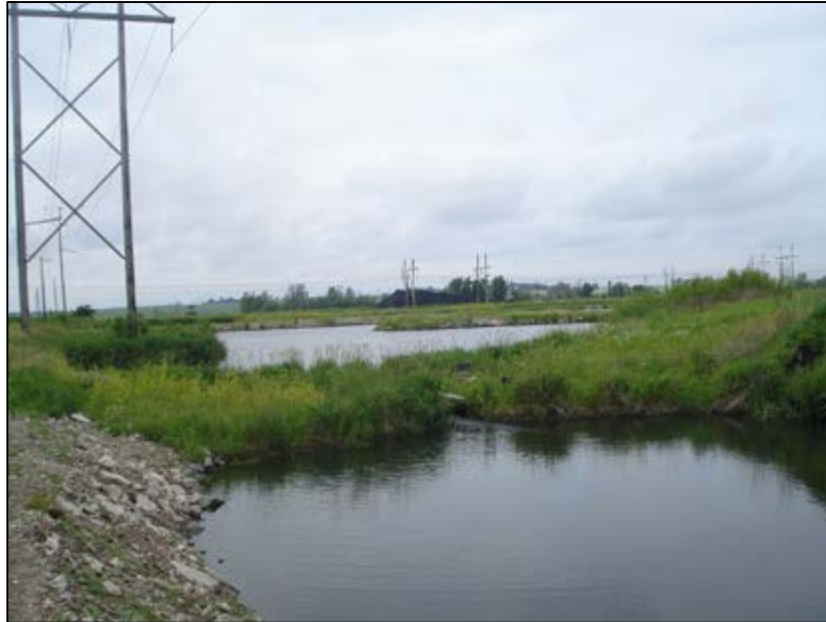
SECP-13

**LOOKING SOUTH AT US SLOPES OF EAST DIKE, INTERIOR, AND OVERFLOW
DIKE BETWEEN SECONDARY AND POLISHING PONDS, TALL VEGETATION**

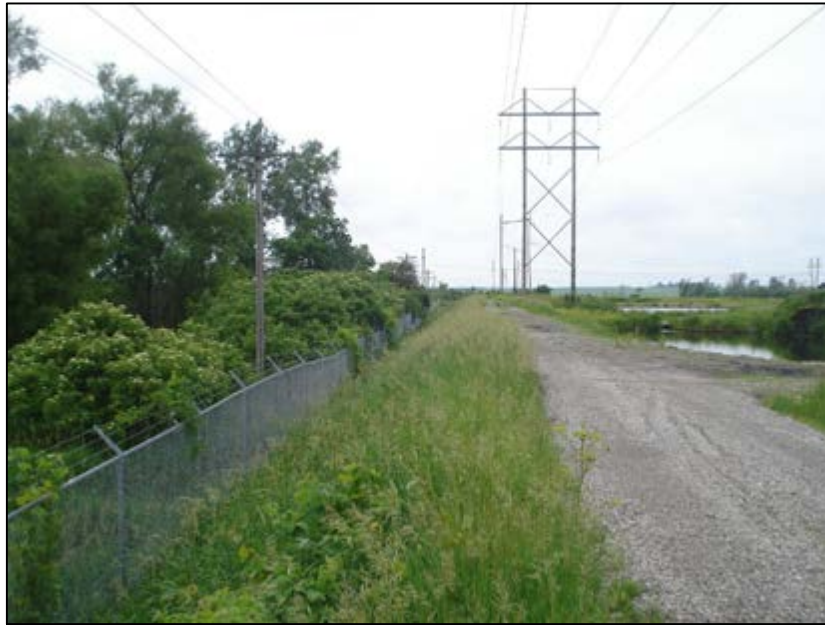
east embankment. This indicates a recent repair and the slopes are in good condition (Photo PP-4). The upstream slopes on the north half of the east embankment were covered with tall grass which prevented observation of the surface of the slopes. Although restricted by these conditions, the upstream slopes viewed from across the pond appeared to be steep and in fair condition (Photo PP-5). The downstream slopes on the east embankment were covered with tall grass which prevented observations of the surface of the slopes. Although restricted by these conditions, no evidence of surface sloughing or other failures were observed on the downstream slopes (Photos SECP-15 and SECP-21).

SECP-15
LOOKING SOUTH AT EAST DIKE CREST AND
DOWNSTREAM EMBANKMENT

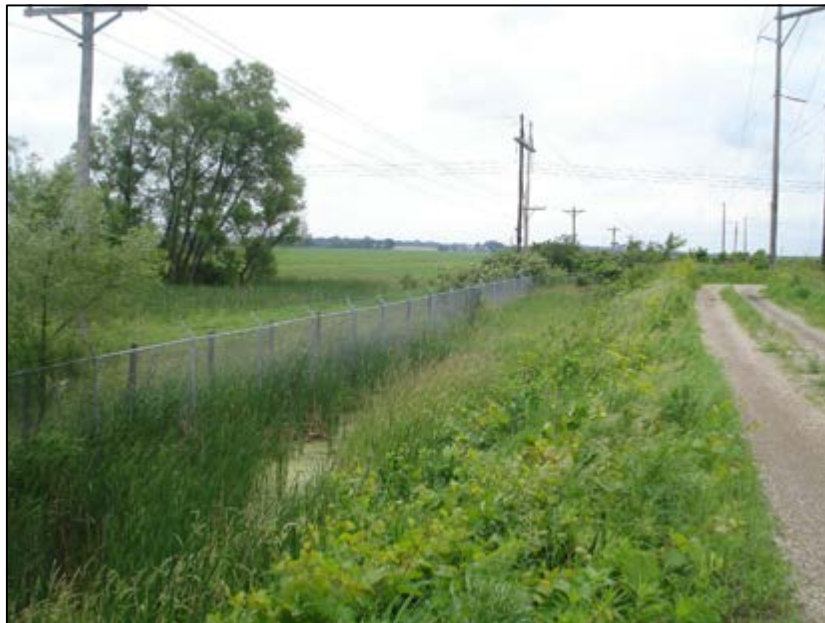
The south and east embankments of the Secondary Pond appear to be the original embankments. Tall grass covered the upstream slopes on these embankments which prevented observations of the surface of the slopes. Based on our observations under these restrictions, the east upstream slope appeared generally to be in fair condition (Photo SECP-13). The south upstream slope was generally in fair condition, but isolated locations of surface slough failures were observed (Photo SECP-4 and SECP-14). The number of locations seemed to increase from east to west. The downstream slopes of the east and south embankment had tall grass which prevented viewing the surface of the slopes (Photos SECP-15 through SECP-18). Based on our observations under these restrictions, the downstream slopes generally appeared to be in fair condition with one exception. The exception consisted of ponded water in an area against the downstream toe on the east embankment. See the following photo presented as Photo SECP-16 in appendix B.

SECP-16
LOOKING SOUTH AT CREST AND DS SLOPE OF EAST DIKE OF
SECONDARY POND, WATER AT TOE OF DOWNSTREAM SLOPE

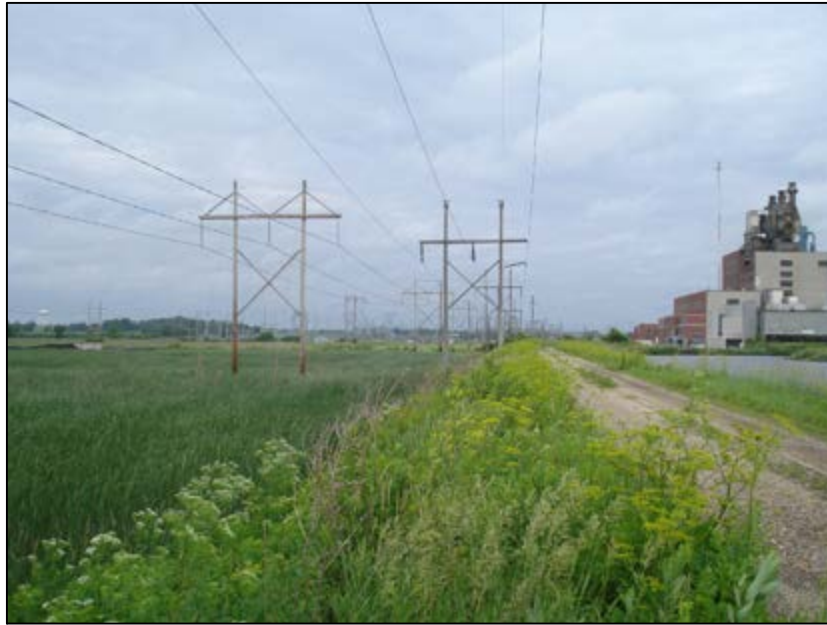
SECP-17
LOOKING WEST AT DS SLOPES AND CREST OF SOUTH
DIKE OF SECONDARY POND, TALL VEGETATION

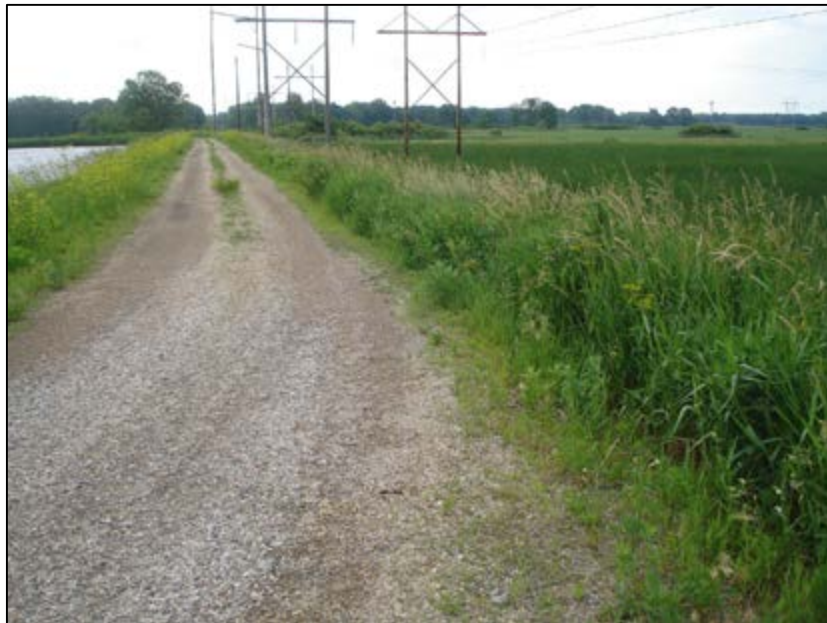
SECP-18
LOOKING EAST AT CREST OF SOUTH DIKE OF SECONDARY
POND, TALL VEGETATION ON US AND DS SLOPES

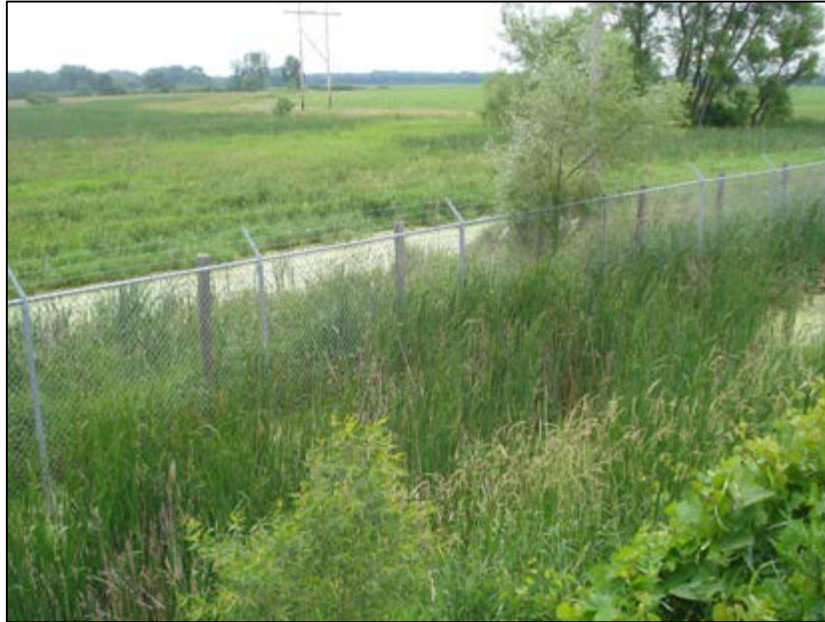
Ponded water was also present to the east of this location (Photo SECP-19). The open field area to the east of the east embankment included wet area vegetation and further east a pond (Photo SECP-20).

SECP-19
LOOKING SOUTHEAST FROM SECONDARY POND,
WATER AT AND BEYOND TOE OF DS SLOPE

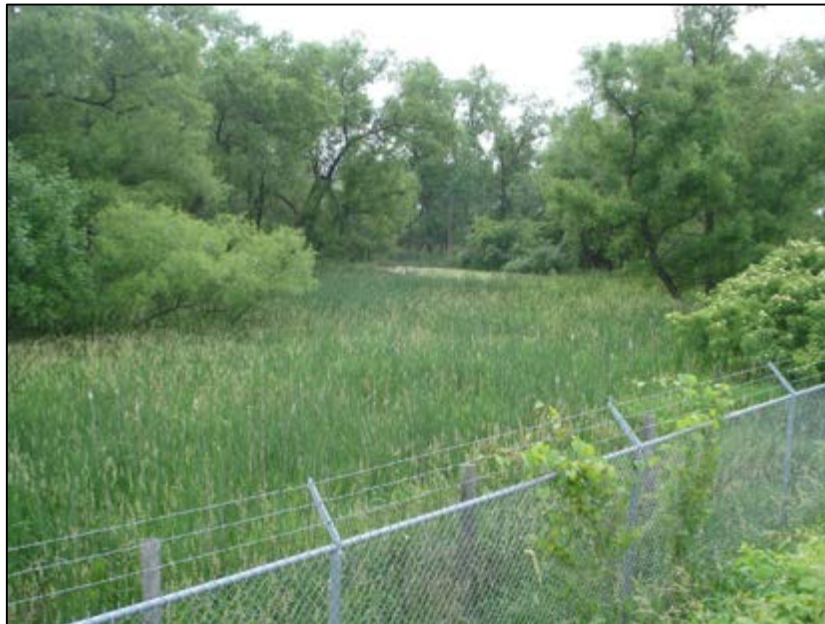
SECP-20
LOOKING SOUTHEAST AT POND TO EAST OF EAST DIKE

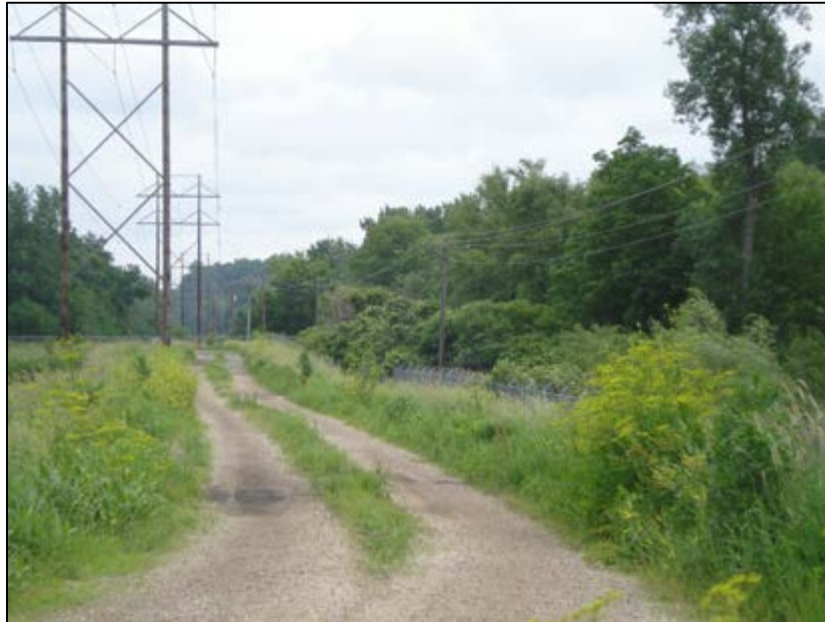
SECP-21
LOOKING NORTH AT CREST AND SLOPES OF SECONDARY
AND POLISHING PONDS, TALL VEGETATION ON SLOPES

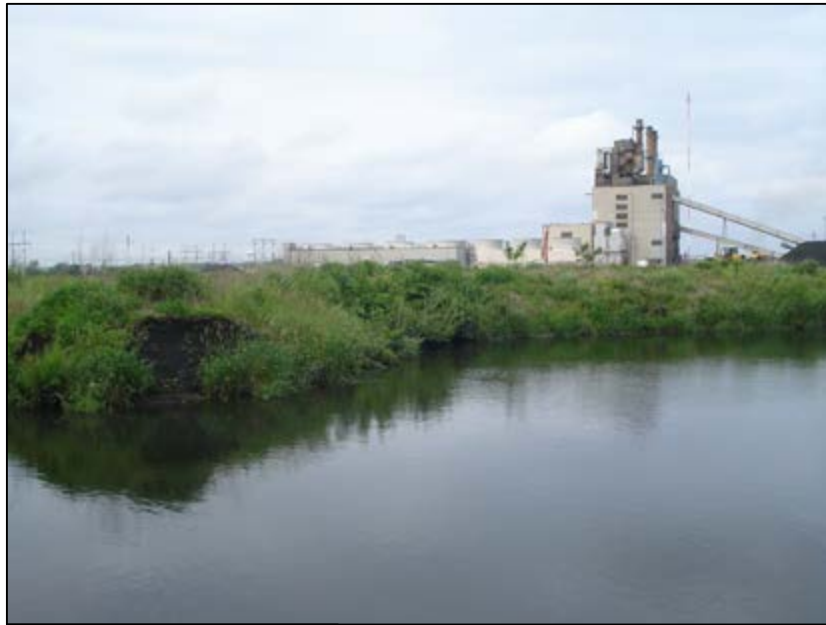
PP-1

**LOOKING SOUTHWEST AT INTERIOR AND WEST DIKE OF POLISHING POND.
STEEP SLOPES, SLOUGH AREAS, AND TALL VEGETATION**

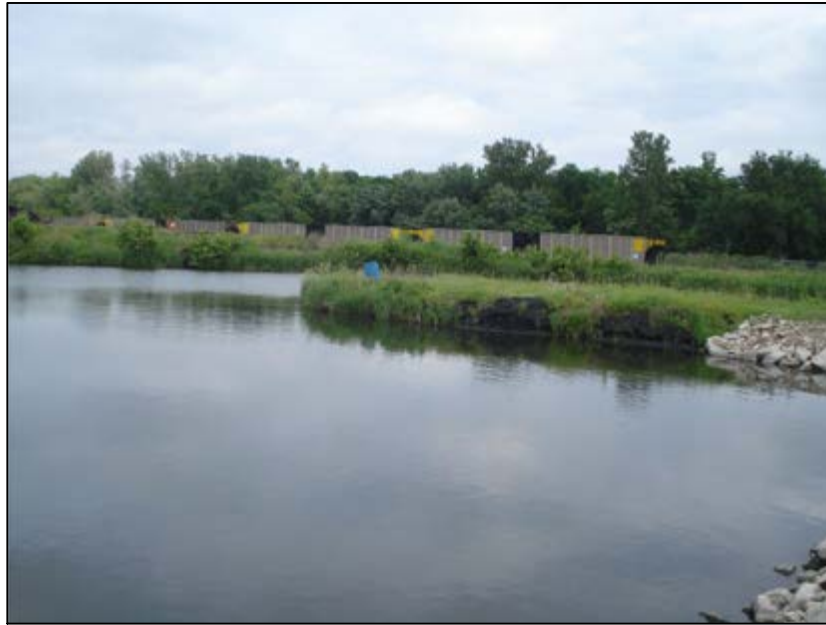
PP-3

**LOOKING NORTHWEST ACROSS POLISHING POND, STEEP/BARE
INTERIOR SLOPES, RECENT REPAIR (RIP-RAP) ON EAST DIKE**

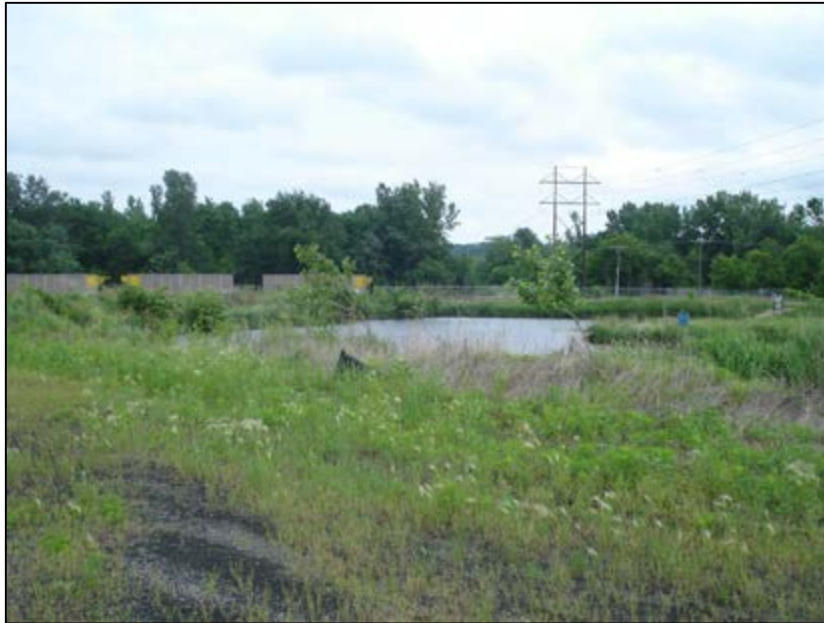
PP-5
LOOKING NORTHEAST AT TOP END OF POLISHING POND.
BRUSHY VEGETATION ON INTERIOR SLOPES

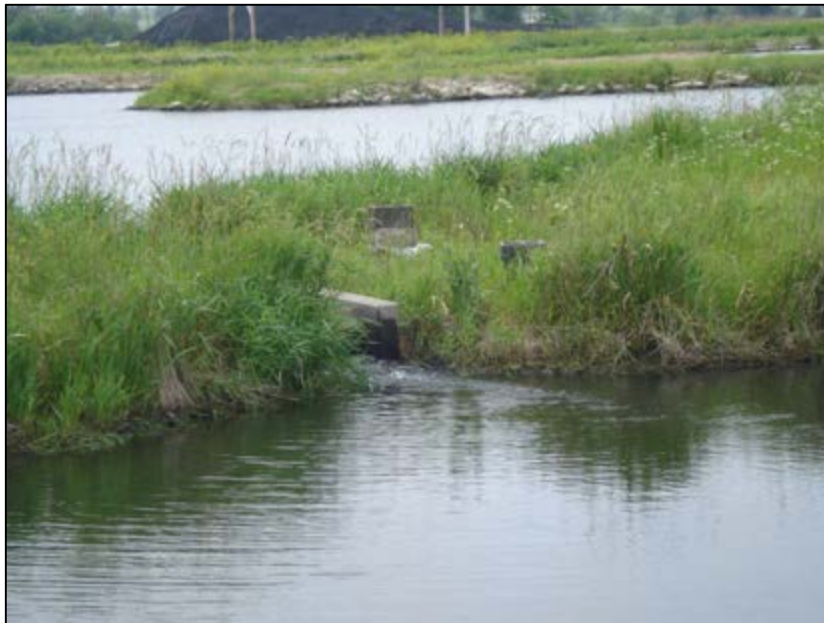
PP-6
LOOKING SOUTHWEST AT WEIR AND OVERFLOW AREA
BETWEEN SECONDARY AND POLISHING POND

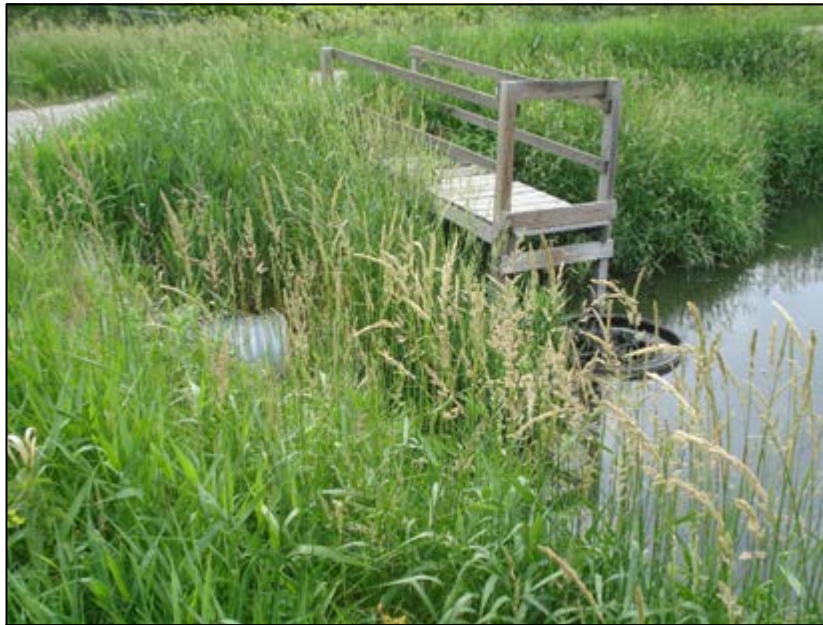
The area at the discharge pond was covered in tall grasses which prevented viewing of the upstream and downstream slopes (Photos DP-1 and PP-4). Although restricted by these conditions, no evidence of surface sloughing or other failures were observed on the slopes.

DP-1
DISCHARGE POND OUTLET STRUCTURE AND
EMERGENCY OVERFLOW INLET

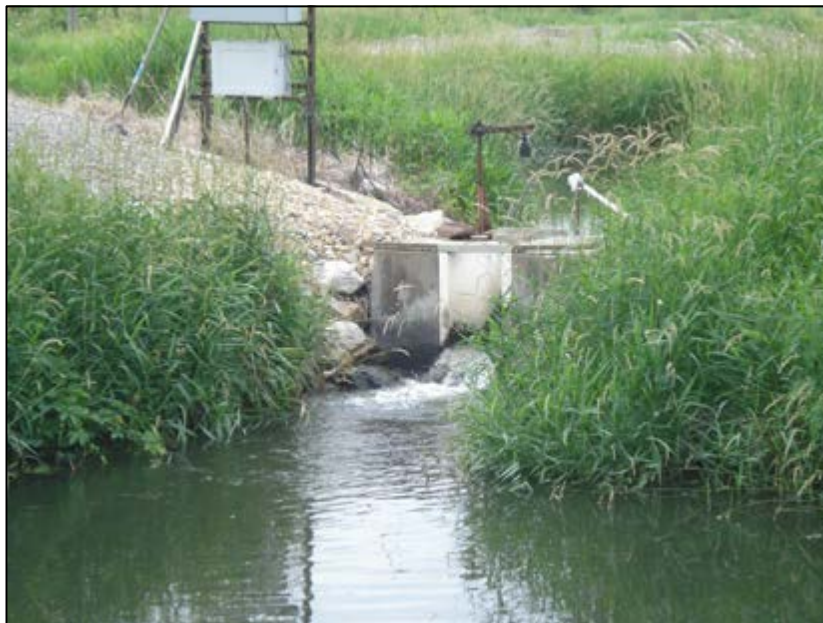
DP-2
LOOKING SOUTH AT DISCHARGE POND PARTIAL FLUME
INLET WITH SOLAR POWERED FLOW METER

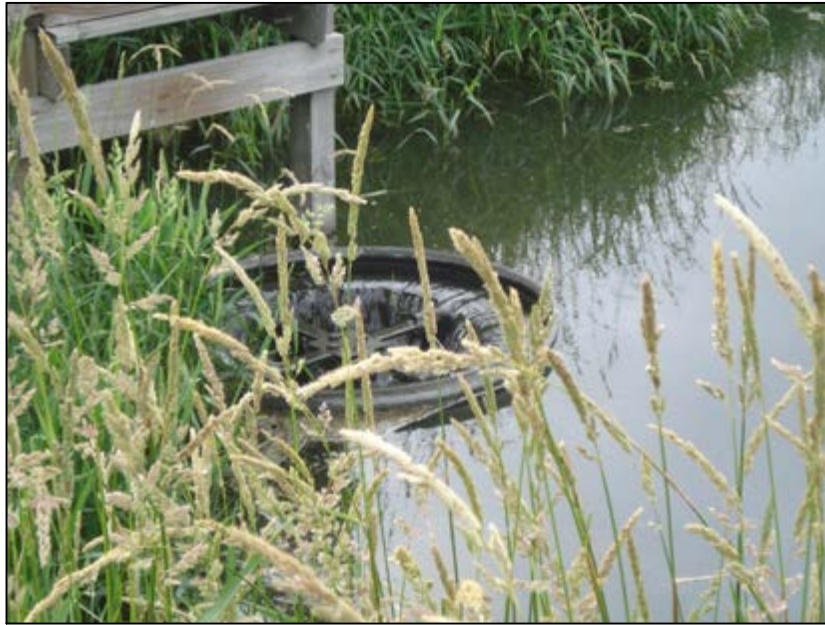
DP-3
DISCHARGE POND OUTLET STRUCTURE

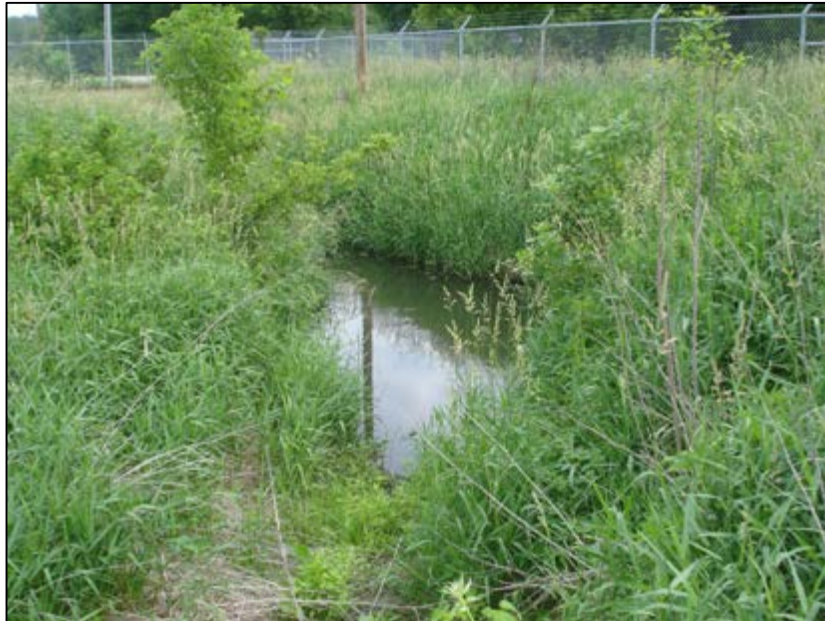
DP-4
BUBBLER POOL/OUTLET DITCH

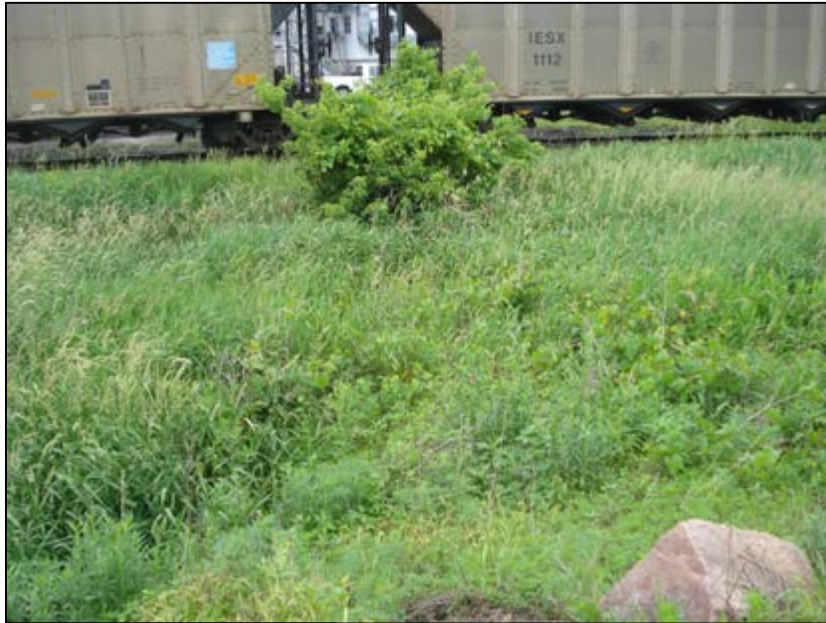
OP-1

TREE MARKS LOCATION OF INLET OF OUTLET DITCH PIPE FROM PROPERTY

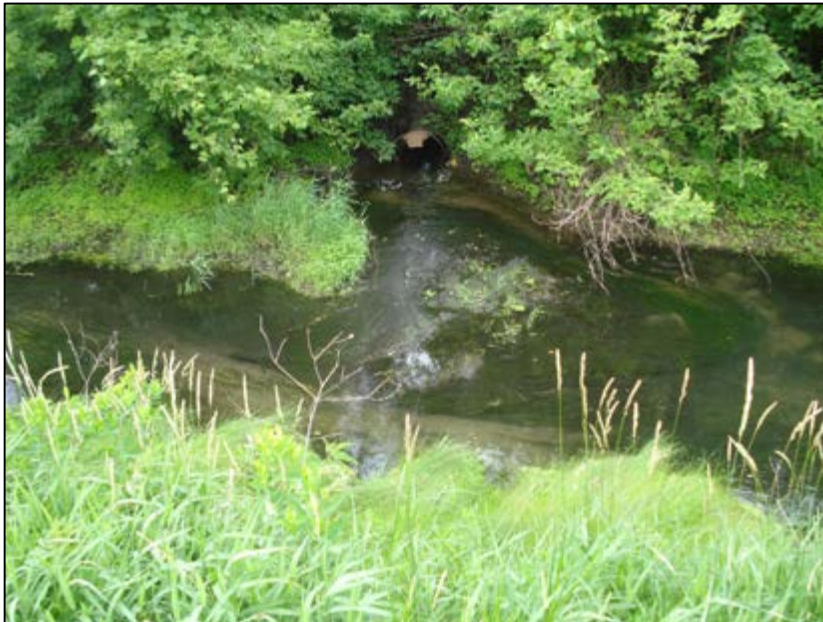
OP-3

LOOKING SOUTH AT OUTLET PIPE TO ROADSIDE DITCH, CORRODED CMP PIPE

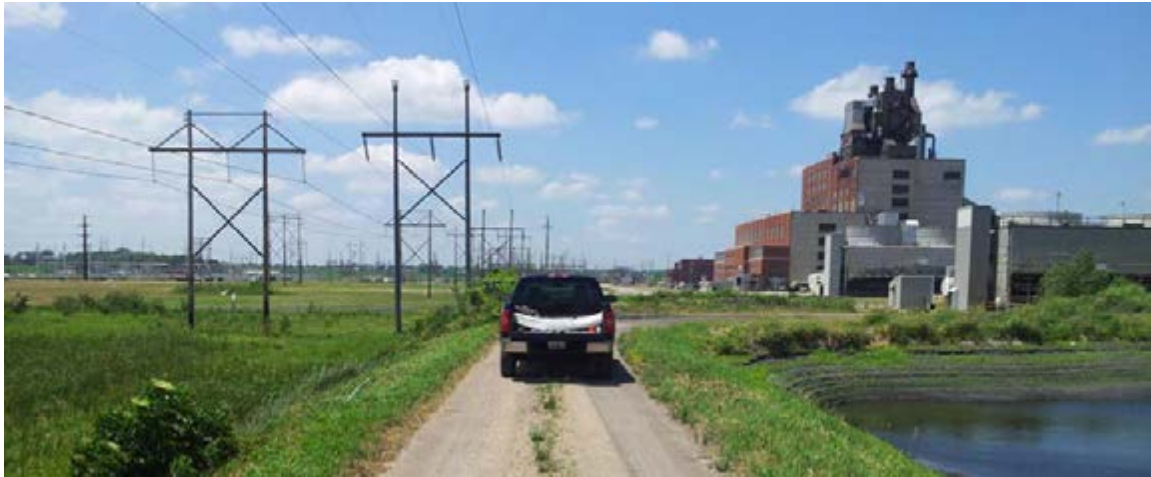
Since water is not being used to sluice bottom ash from the boilers, the water elevation in the ponds has dropped dramatically, Photo 1. The ponds still receive storm water runoff, blow down water from the cooling water loop, sump water and air compressor cooling water. Without the sluicing water, the water elevation in the main ash pond is at the ground surface elevation outside the pond, Photo 1. Cattails growing at the outside base of the embankment indicate that the groundwater is at or near the ground surface.

Photo 1 - South western corner of the Main Ash Pond looking west. (Aether 6/19/2012)

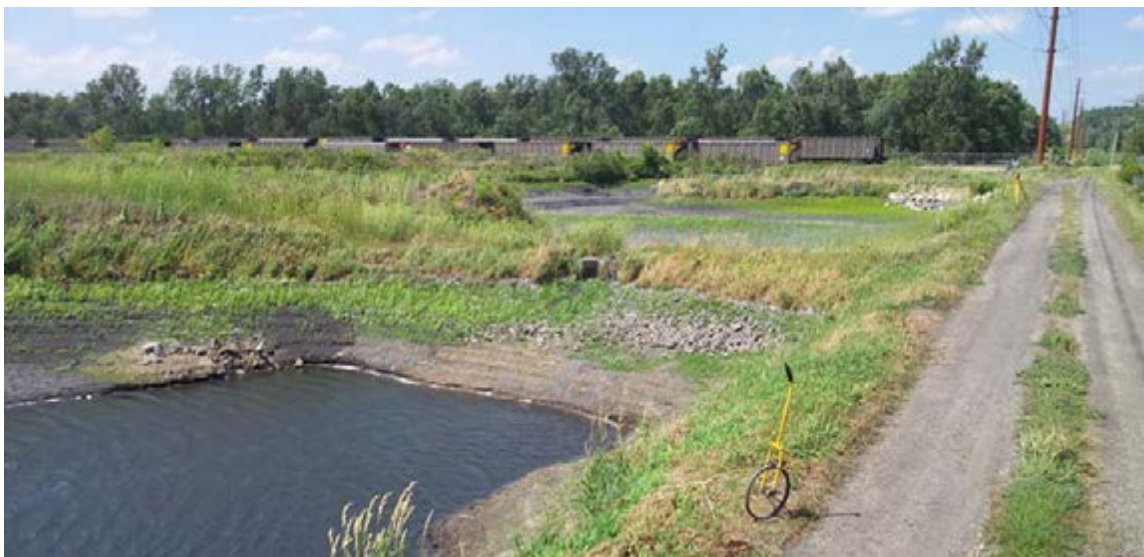
Without the bottom ash sluicing water, there is no flow to the Polishing pond which shows a dry bottom, photo 2.

Photo 2 - Looking north along the eastern outer embankment. (Aether 6/19/2012)
